Mechanisms and kinematics of three translational slides along the North Saskatchewan River Valley, Edmonton

K. W. Soe Moe

BGC Engineering Inc. Edmonton, Alberta, Canada

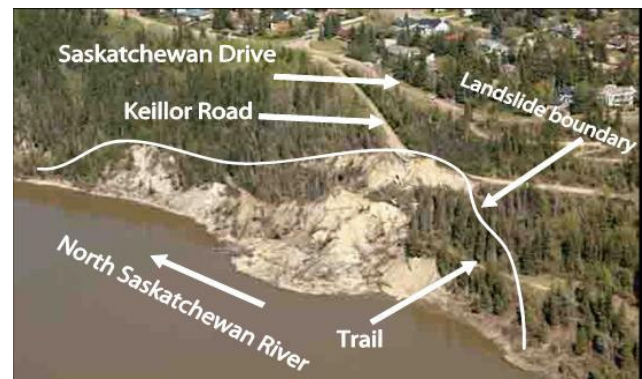
Figure 1 Keillor Road landslide (May 2005, the City of Edmonton)

The Keillor Road Landslide occurred in the fall of 2002 on the outside bend of the North Saskatchewan River, where Keillor Road traverses down from a flat upland area to a low level terrace (Figure 1). Due to the failure, a 5 m deep graben appeared at the head of the displaced material and the toe of the slope moved 22 m into the river.

The total volume of soil and rock involved in the landslide was in the order of $100,000 \text{ m}^3$. After the 2002

failure, continued slope movements caused further downward movement of the graben over a period of 2 years, resulting in a further 3 m retrogression of the main scarp. Movement of displaced materials continues to be observed up to the present day.

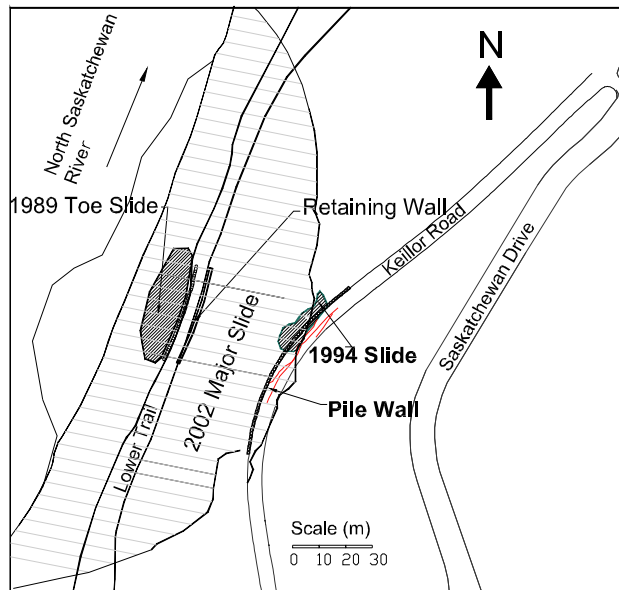
Figure 2 Map of slide area and site investigation plan

The Keillor Road Landslide started as a minor toe failure in 1989 causing some damage to a recreation trail at the toe of the slope (Barlow 1989). Fill had previously been placed to remediate a drop at the edge of the trail. After failure, a concrete retaining wall was constructed at the downslope edge of the trail to locally protect the trail from the effects of further instability (Figure 2).

The wall performed satisfactorily until August 2001 when a crack was observed across the roadway and the concrete wall. With time, the crack developed into a vertical scarp and a major failure occurred in the fall of 2002. The scarp was 50 m wide at the crown but widened to nearly 200 m at the river level. When the failure occurred, the head of the displaced material moved downward forming a graben. The main body of the slide translated along a horizontal plane in the bedrock.

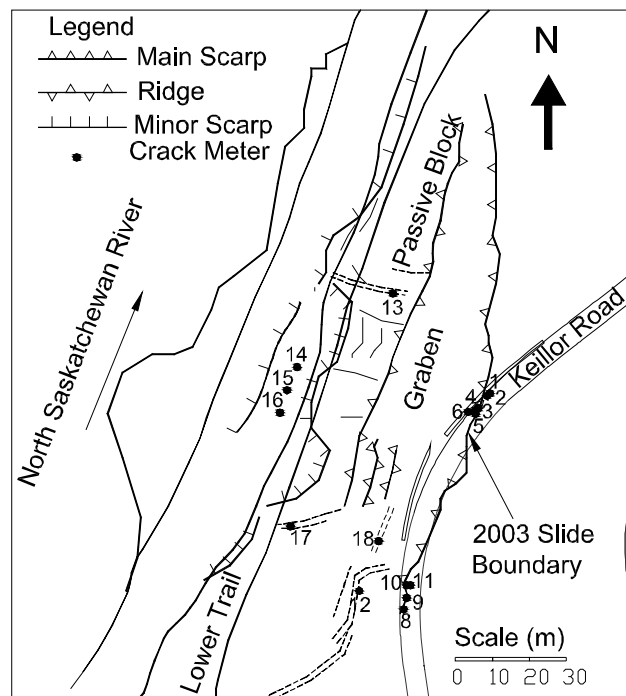
Figure 3 Landslide map of Keillor Road (2003)

After the major failure in 2002, a field observation program was carried out to monitor the post-failure slope movement. Landslide features such as the graben, tension cracks, scarps, and ridges were mapped monthly in the spring and the summer of 2003 and 2004 (Figure 3). A total station survey was conducted in the spring of 2003 and 2004 to monitor movements of the upper pile wall and to provide a cross sectional survey of the landslide topography (SoeMoe et al. 2005).

In the fall of 2002, 18 crack meters (CM) were installed in the displaced material to monitor the surface expression of the slope movements (Figure 3). Vertical and horizontal movements of the CM were monitored regularly in the spring and summer of 2003 and 2004. As the landslide progressed, significant slope movements occurred and the middle part of the main body slid into the river in July 2004. The maximum movement of the counter scarp was 3 m toward the river from May of 2003 to May of 2004. Minor scarps which formed at the lower

portion of the displaced material were attributed to retrogressive failure.

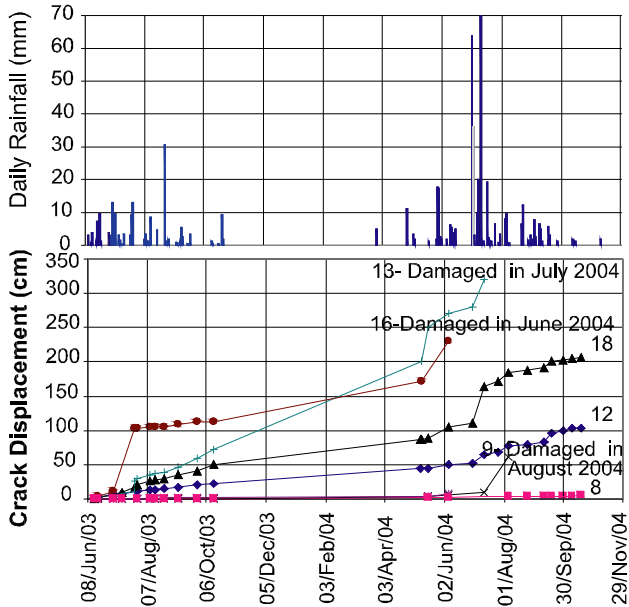
Figure 4 Horizontal displacements of crack meters

The horizontal movements of CM are presented in Figure 4. CM-13 was located in the initial toe of the slide and slid down to the river after a period of heavy rainfall in July 2004. CM-16, located at the toe of the slide, was damaged by the slide in early June of 2004. Maximum movements were observed at the centre of the slide. As shown in Figure 15, the recorded crack displacements increased significantly after periods of heavy rainfall.

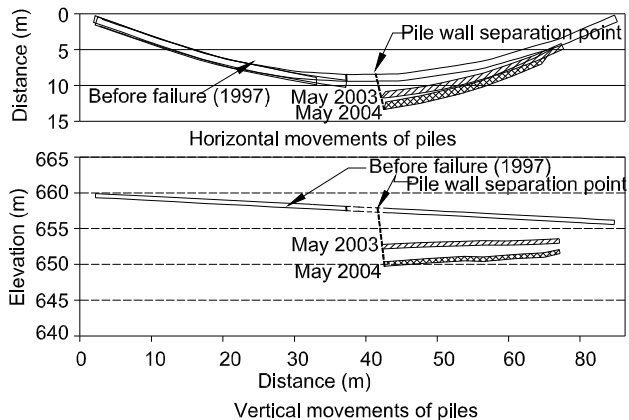
Figure 5 Movements of the cast-in-place piles

Part of the upper pile wall was located inside the graben and settled together with the displaced material. The coordinates of the top of the pile wall were surveyed in May 2003 and May 2004 (Figure 5). The maximum recorded horizontal and vertical movements in 2003 were 2.3 m and 5 m, respectively. In 2004, an additional 1.7 m and 2.3 m of movement were measured, respectively.

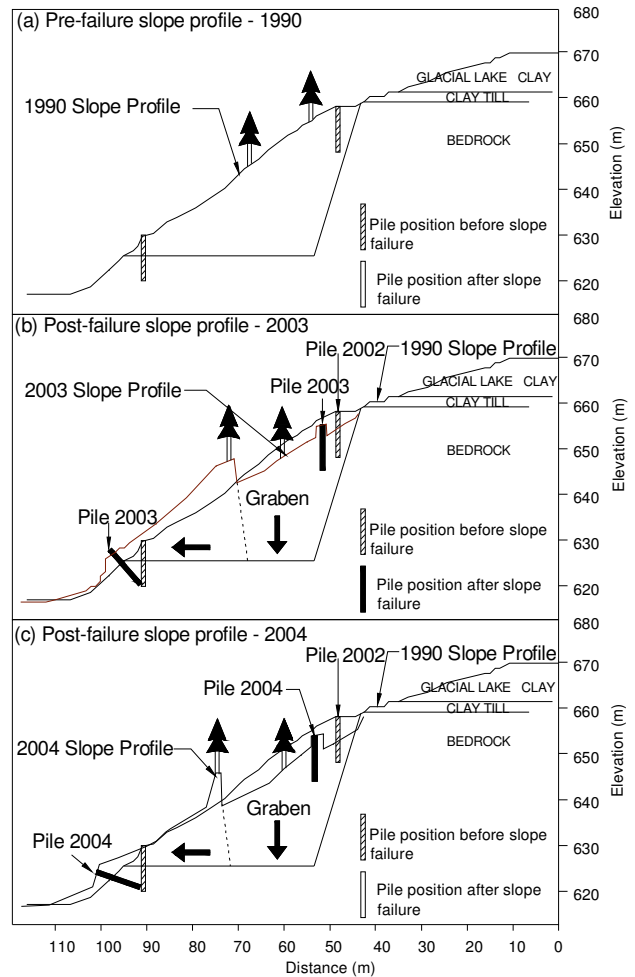
Figure 6 Slope profile survey (Pre-failure, 2003 and 2004)

Movements observed at the Keillor Road Landslide revealed the development of landslide stages with time. At Keillor road, initial movements started as a toe failure in 1989 and a major failure occurred in the fall of 2002. Inclinometers installed prior to the major failure revealed the development of the main scarp. A comparison of the original slope cross-section with the surveyed post-failure cross sections from 2003 and 2004, as well as the attendant pile movements, are shown in Figure 6. As shown, the failure mechanism extended below the pile wall. Downward movement of the material inside the graben and the translational movement of the main body can be seen in Figures 6b and 6c. As the landslide progressed, more cracks appeared in the main body as a result of slope deformation. The upper pile wall at Keillor Road moved downward, and piles at the trail near the toe tilted forward as the displaced material pushed the piles toward the river.

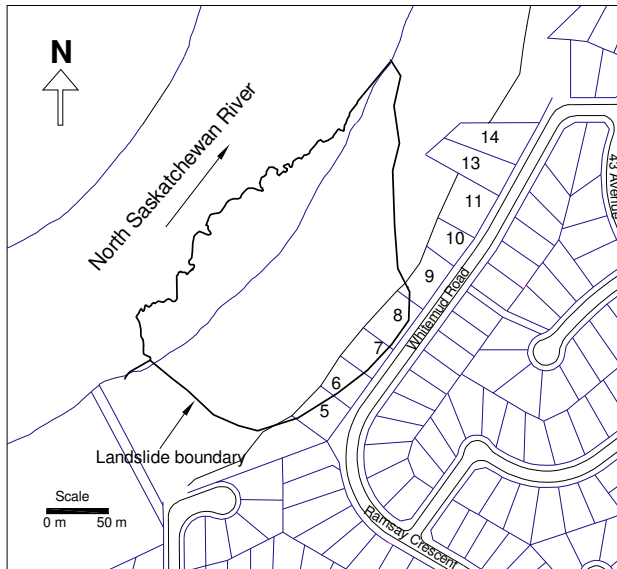
Figure 7 Location of Whitemud Road slide

On the morning of October 23, 1999, a large landslide occurred along a 270 m section of the North Saskatchewan River Valley in Edmonton (Barlow and Froese 2000). The failure affected seven residential lots on the west side of Whitemud Road between the intersection of Ramsay Road and 43rd Avenue (Figure 7). The upper two-thirds of the valley slope slid along a rupture surface located in the bedrock. As the failure progressed, the soil and rock above the failure plane cascaded over the bedrock and slid into the river. The total volume of soil and bedrock involved in the landslide was in the order of 250,000 m³. After the initial failure, 50,000 m³ of this material was displaced into the river channel at the toe of the slope. As the main body translated along the surface of rupture, subsidence occurred at the head of the displaced material, resulting in a vertical drop of up to 18 m.

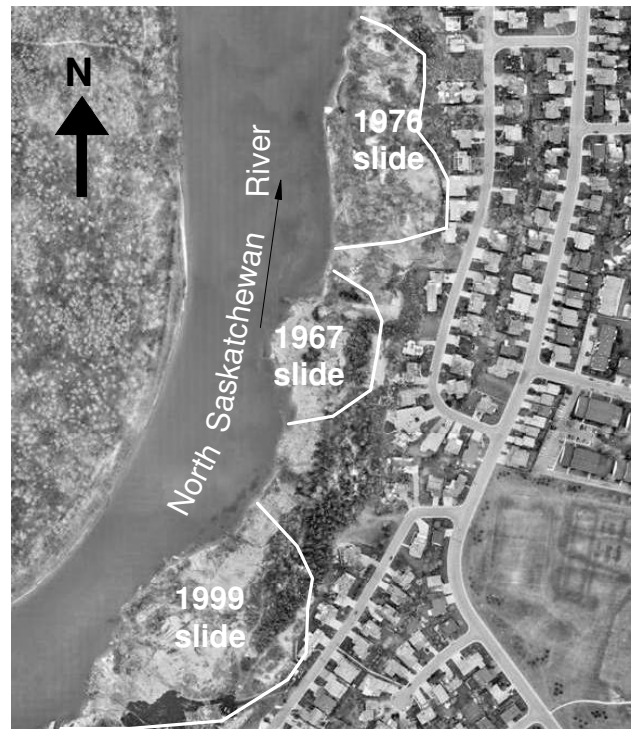
Figure 8 Landslides along Whitemud Road (May 2002, City of Edmonton, Line 17E, Scale 1: 5000)

Prior to the major landslide in 1999, several movements had occurred downstream of the 1999 landslide location (Figure 8). In 1967, a failure occurred 300 m downstream of the 1999 landslide location but the failure did not affect the residential properties behind the valley wall. In 1976, a second failure occurred north of the 1967 failure involving the overlying glacial deposits and the bedrock. Significant observations before the 1999 landslide are listed below.

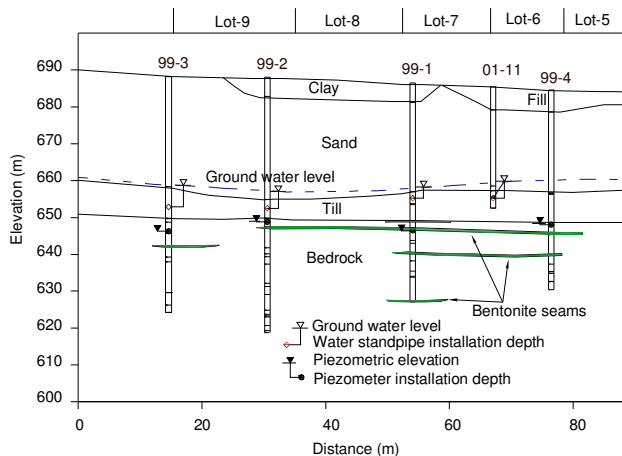
Figure 9 Cross-section along Whitemud Road

Post failure borings (Barlow 2005; Barlow and Froese 2000) revealed that the bedrock comprises interbedded layers of mudstone, clay shale and sandstone with thin bentonite layers (Figures 9).

The bedrock is Upper Cretaceous in age and part of the Horseshoe Canyon Formation of the Edmonton Group (Bayrock and Hughes 1962). When exposed to weathering processes, the bedrock swells and softens, particularly in areas of seepage discharge. The sandstone varies from a low plastic sandy clay to a weakly cemented soft rock. The mudstone and clay shale are generally hard, massive, high plastic and without any distinct fissility. Three separate bentonite layers with a

varying thickness from 50 to 400 mm were identified from deep borings (Figure 9).

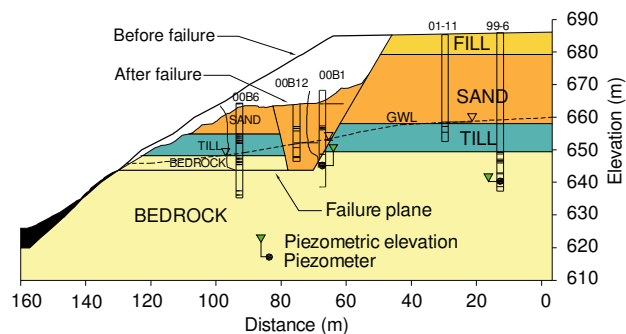
Figure 10 Pre and post-failure cross section of Whitemud Road Landslide

The major movements in the Whitemud Road landslide occurred within one day (Barlow and Froese 2000). A distinct graben feature formed at the head of the displaced material as the main body translated along a weak plane in the bedrock. Figure 10 presents pre-failure and post-failure cross-sections of the slide area and identifies soil and rock layers deduced from the drilling information (SoeMoe et al. 2006).

As shown in the figure, the failure geometry of the Whitemud Road slide consisted of a steeply dipping main scarp and a surface of rupture seated in the bedrock. Boreholes advanced inside the displaced material revealed two different profiles. The borings inside the graben encountered mostly sand, indicating most of the materials inside the graben were from the overlying sand deposit. Boreholes drilled outside of the graben boundary revealed an almost undisturbed stratigraphic profile of sand and till overlying bedrock, indicating that these materials translated along a weak plane.

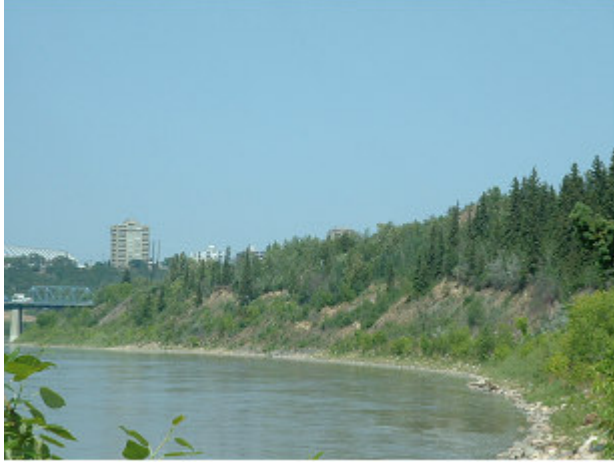
Figure 11 River valley view of Forest Heights Park

Immediately below the flat upland area, steep scarps and grabens occupy the valley wall. Transverse ridges and cracks are also found throughout the mid-slope area. A terrace is located 25 to 30 m below the valley crest, which is crossed by a lower recreational trail. The slope below this terrace is also irregular with transverse cracks and scarps. The North Saskatchewan River is located 10 to 15 m below the terrace level. Glacial till is exposed at the toe of the slope in northern part of the park, while the remaining portion of the toe is covered by the displaced bedrock. Varying degrees of slope deterioration are evident and retrogressive slumps are found in several locations.

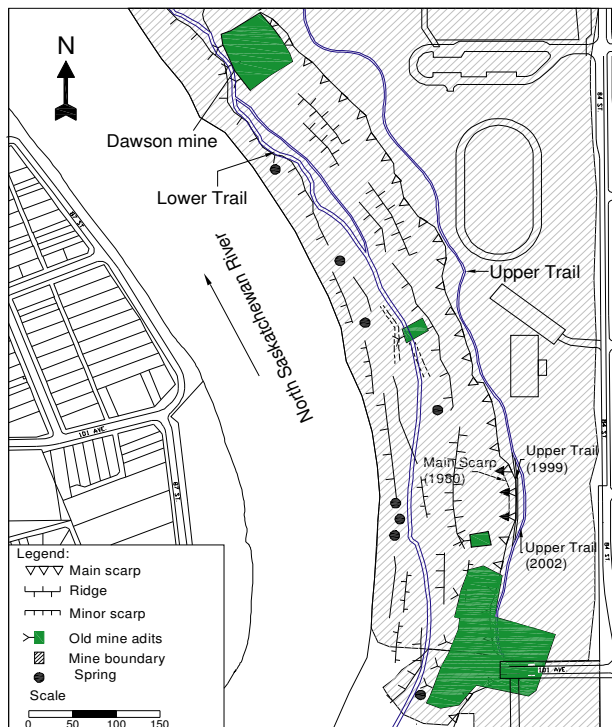
Figure 12 Map of Forest Heights Park (modified after Taylor, 1971)

Several small coal mines operated within Forest Heights Park in the early 1900's (Taylor 1971). These mines had reported cave-in and subsidence problems in the past (Figure 12). Coal was extracted from two coal seams, the Weaver seam and the Clover Bar seam, located 30 m and 70 m below the slope crest respectively (Godfrey 1993). Although there were several mines in the study area, only the Dawson mine worked the deeper Clover Bar seam, while the other mines worked the shallower Weaver seam (Taylor 1971).

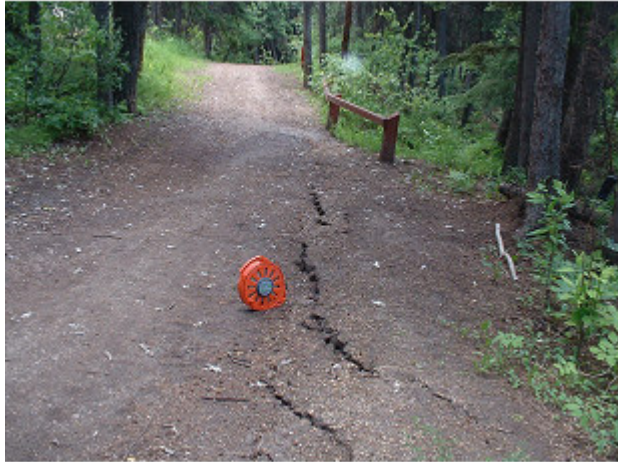
Figure 13 Tension cracks in the lower trail

In June of 2005, the level of the North Saskatchewan River increased above the elevation of the toe berm. This flooding event caused significant toe erosion, and tension cracks soon appeared along the lower trail as shown in Figure 13.

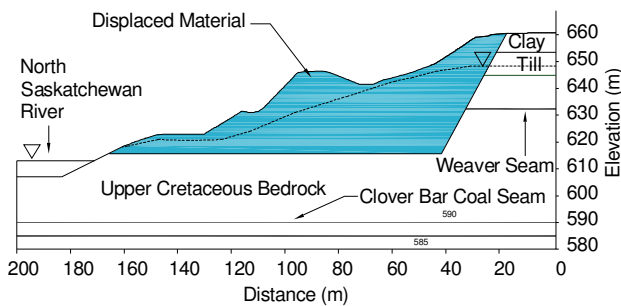
Figure 14 Cross section of the valley wall together with coal seam elevations

Coal mining below the area appears to have caused the weakening of overlying bedrock, accelerating the propagation of cracks deeper into the bedrock. This significant weakening of the bedrock would also have facilitated subsequent softening of the bedrock by allowing increased groundwater flow through the cracks, accelerating the softening processes in the bedrock. Finally, hydrostatic pressure may have built up within the cracks during periods of heavy rainfall, which in turn would significantly reduce the factor of safety of the valley wall. Since most of the old mine workings extracted coal from the Weaver seam, located at mid height of the valley wall, it is probable that coal extraction from the Weaver seam had the greatest impact on the stability of the valley wall. The effects of mining the Clover Bar coal seam appeared to be minimal, since this seam is located 25 m below the failure plane. The location of the coal seams together with the displaced material is shown in Figure 14.
